J.A.G. Home Inspection

PROPERTY INSPECTION REPORT

21 June 2017

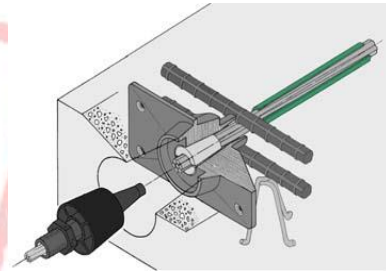
The exposed / rusty nails may cause the Post Tension Cables (PTC) to become exposed and/or there were exposed reinforcing steel and/or tendons in the grade beam. This foundation was strengthened by post tensioned cables. The Post-Tensioning Institute (PTI) recommends that tendon ends be covered with at least 1" of grout. These should be sealed to prevent corrosion and potential failure of the cable. Do *not* use bagged cement or any product containing calcium chloride or other material deleterious to pre-stressing steel. See the illustration of the tendon "anchor" and "live" ends. The Post Tensioning Institute (PTI) notes a requirement for a brass plate or stamp within the concrete floor of the garage space or metal tag on the water line noting: Post Tension Slab: Do not cut or core. Note that this requirement is for protection against repairs which may damage the cables and create additional damage to the foundation. These markings were not observed

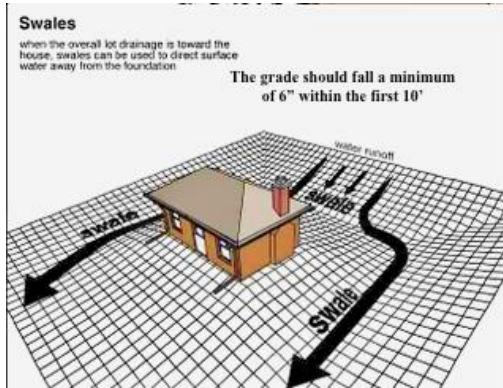
The soil levels were high against isolated areas of the foundation grade beam. When soil levels and vegetation are high against the face of the foundation it promotes water penetration, wood rot and insect infestation. Brick veneer wall cladding should have about 4" of clearance between the soil and the first course of bricks, and other materials should have 6" of clearance between other materials and the soil.

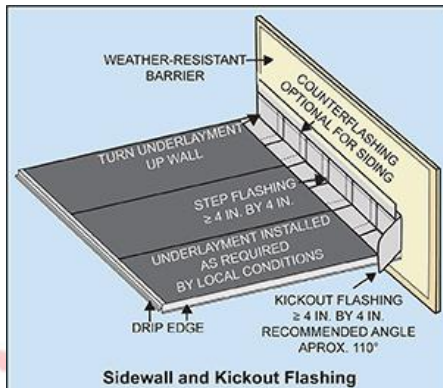
The flashing noted between the side walls and roof was hemmed (also known as "J" or "L" flashing). Flashing against a vertical sidewall should be the *step-flashing type or method*, a minimum of 4" high and a minimum of 4" wide and turned out at the end of the vertical sidewall in a manner that directs water away from the wall and onto the roof and/or gutter. **NOTE: While this flashing may be acceptable by Authorities Having Jurisdiction and Code, it may not meet the manufacturer's installation requirements (install shingles on a smooth surface).**

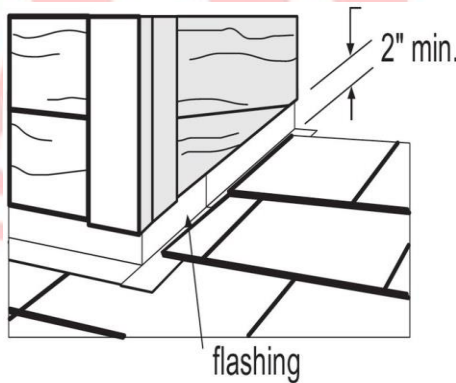
The vertical wall siding above the roof was in contact, or near contact, with the roof cover. The James Hardie Corporation’s installation instructions state that a “minimum 2” clearance between James Hardie products and roofs, decks, paths, steps and driveways.” This is intended to prevent wicking of water run-off which may degrade the material and shorten its useful life.

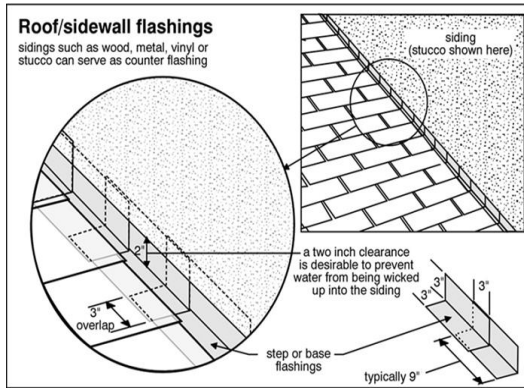
The vertical wall siding above the roof was in contact, or near contact, with the roof cover. A minimum 2” clearance between roof decks and siding material is recommended. This is intended to prevent wicking of water run-off which may degrade the material and shorten its useful life.

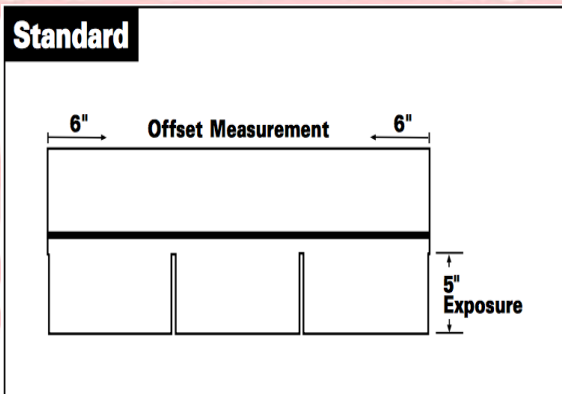
The shingles appear to be spaced beyond manufacturers installation instructions. 3 Tab shingles indicate a maximum of 5" exposure; dimensional/architectural shingles allows a maximum of 5 1/2" exposure.

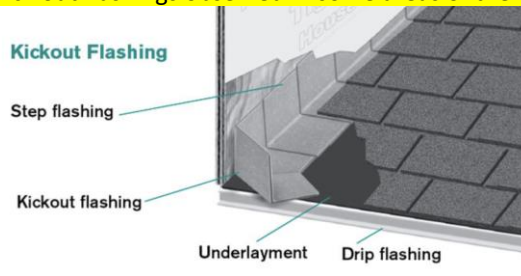
No kick out flashings observed in some areas of the roof covering

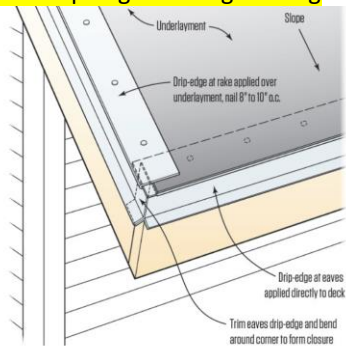
Rain drip edge flashing missing

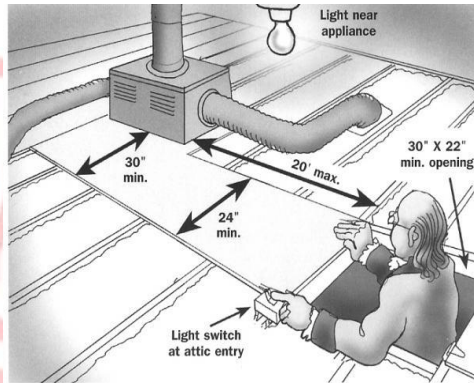
1. There was no **continuous, unobstructed or safe** passageway between the head of the stairway and mechanical equipment. When equipment, which may require service, is located within the attic space, a continuous passageway at least 22" wide should extend from the attic access to the equipment which should be located no more than 20' distant.
2. There was no **landing platform at the top of the attic stairway**. Decking should be installed at the top of the stair to minimize the risk of stepping onto, and falling through, the ceiling cover.
3. There was no **access to the attic space above the finished garage space**. Attic spaces greater than 30" high measured from the top of ceiling framing to the underside of the roof framing, and larger than 30 sqft. require a minimum of a 22"x30" opening.

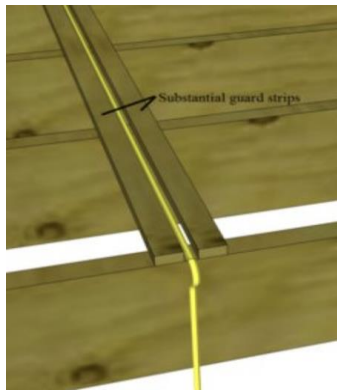
Wiring not protected within 6' of scuttle entrance. Attics and roof spaces that are accessible, the cable shall be protected by substantial guard strips that are at least as high as the cable. Where this space is not accessible by permanent stairs or ladders, protection shall only be required within 1.8 m (6 ft) of the nearest edge of the scuttle hole or attic entrance. See Code **NEC 320.23** Below:

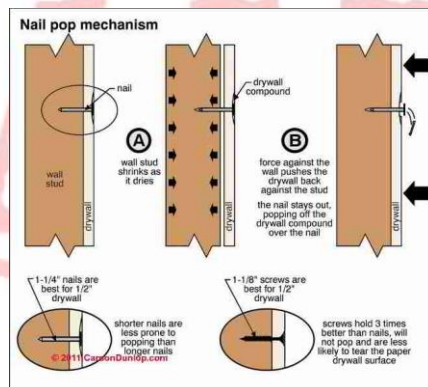
There were cracks and/or nail pops within the angular ceiling joints of one or more rooms. Cracks in angular joints in ceiling covers are typically a result of the house’s dehumidification process and thermal movement and not necessarily an indicator of settlement or structural movement requiring repair. Such cracks observed, in this inspector’s opinion, were not deemed to be deficient or in immediate need of repair.

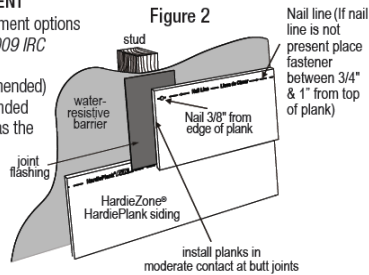
One or more of the following joint treatment options are required by code (as referenced 2009 IRC R703.3.2)

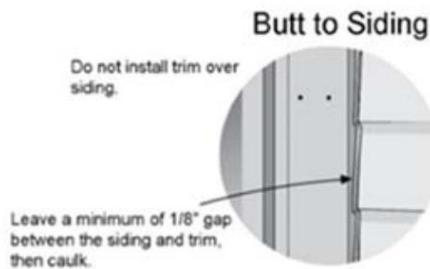
The fiber cement siding was installed beneath the trim rather than butting to the trim. A minimum 1/8" gap required between siding and trim.

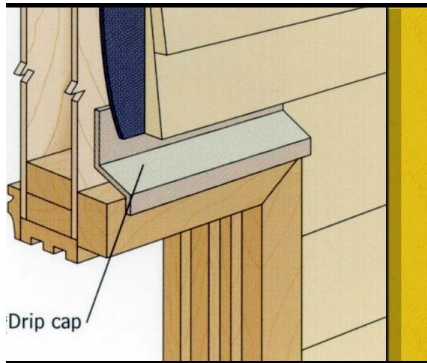
The masonry window sills had a slope less than 15 degrees. This slope is recommended by the *Brick Institute of America* to ensure proper moisture run-off minimizing the risk of penetration and damage. We recommend that window-to-wall joints be monitored and re-caulked or otherwise sealed as necessary to minimize water penetration, reduce draft and improve energy efficiency at these areas. While technically deficient, the slope was positive (i.e. away from the window) and we make no recommendation for repair.

There was no flashing or weep holes observed beneath the masonry sill. While technically deficient, we make no recommendation for repair.

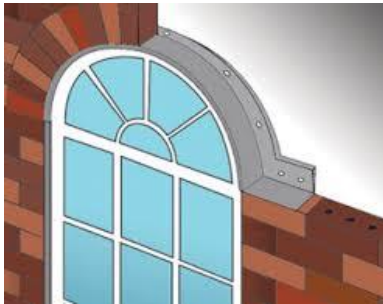
Weep holes not open, missing, and/or improper spacing. Weep holes should be located “in the outside wythe of masonry walls at a maximum spacing of 33 inches on center” and should not be less than 3/16” in diameter and should be located immediately above the flashing. The purpose of weep holes is to allow water which may penetrate behind the brick veneer to drain outside the structure. These should not be plugged or sealed, doing so may prevent moisture drain from behind the masonry and will not prevent insect infestation. Mulch, soil, etc. should not be allowed to cover these holes to minimize the risk of Wood Destroying Insects (WDI) infestation.

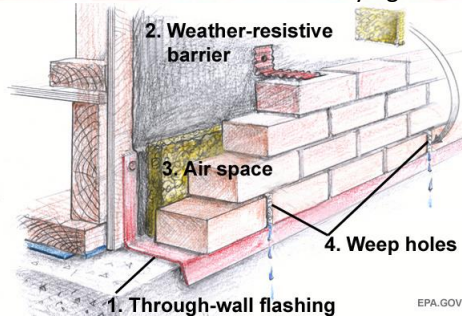
Flashing was either missing or improperly installed above cavities in the masonry veneer. Flashing above cavities in masonry walls should be *installed above* the steel lintel and should *extend through the wall out to the front edge* of the steel lintel. Note that we were not able to evaluate the window or door wraps behind the masonry which may be intended to serve as flashing. While technically deficient we make no recommendation for repair.

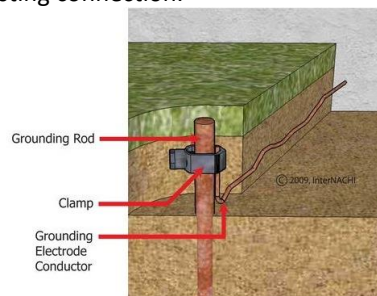
The clamps at the ground rods did not appear to be proper (i.e. rated for ground rods). The clamp observed was listed as a pipe clamp for metal water or gas lines. We recommend the use of a brass “acorn” style clamp, U.L. listed and approved for direct burial, on the ground rod for a more secure, longer lasting connection.

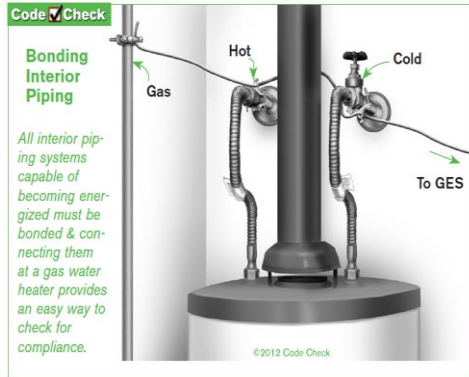
Metallic water pipes were not bonded across the Water Heater.

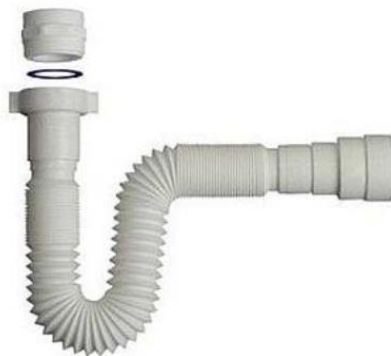
There was an unlisted drain line installed beneath the bathroom sink. Flexible drain lines are considered to be temporary repairs due to the propensity of the ridges to trap oils, hair, debris, etc. leading to blockage. We recommend that temporary drain lines be replaced.

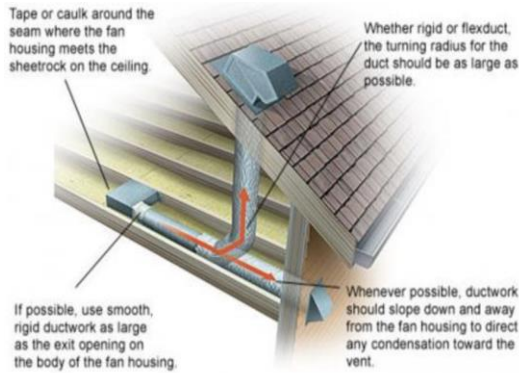
The air removed by every mechanical exhaust system should be discharged to the outdoors. Air should not be exhausted into an *attic, soffit, ridge vent or crawl space.*
