J.A.G. Home Inspection

PROPERTY INSPECTION REPORT

21 June 2017

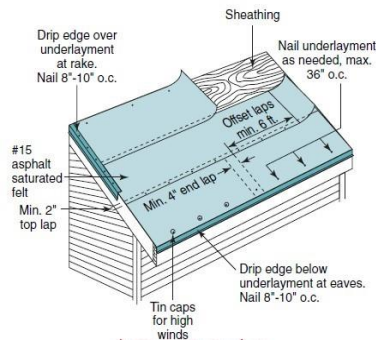
FIGURE 2-2 Underlayment for Asphalt Shingles.

The underlayment should extend down to and over the drip edge at the eave and be installed beneath the drip edge at the rake. The installation of the drip edge at eaves and rakes could not be observed or evaluated in all areas without damage to the seal(s) beneath the shingles. These shingles were sealed at the eave and the underlayment could not be observed or evaluated. Note that, in this inspector's opinion, having the shingles sealed to minimize wind event damage is preferable to observation of the underlayment.

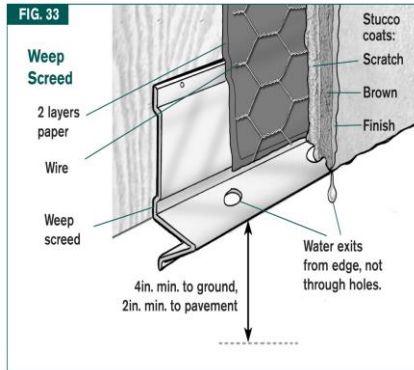
1. Fascia / trim boards are water damaged at some areas
2. Mortar is separated or missing in some areas
3. Caulking / Sealant separated or missing in some areas
4. Some cracks in the brick, stone, or stucco siding
5. Wood siding is water damaged in some areas
6. Siding / shingles are cracked, loose, or missing
7. Some siding fasteners are backing out
8. Flashing missing and / or incorrectly installed
9. Overlap on cement board < 1 1/4" inch
10. One or more areas were obstructed
11. Other Water Penetration Areas at Exterior Walls
12. Inadequate clearance between siding and grade
13. Stucco/Brick less than 2" clearance to surface
14. Stucco terminating below grade

Written Opinion: *The exterior siding displays signs of significant structural movement and should be evaluated further by a structural engineer. Refer to the photos above.*

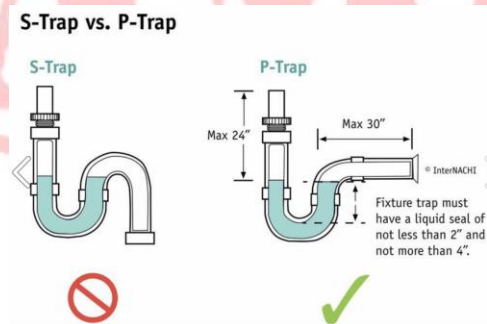
1. Incompatible connecting devices
2. Caulking or grout missing or damaged
3. Vegetable sprayer inoperable
4. Leakage around sink(s)
5. Hot and cold water reversed
6. Loose or damaged faucet handles
7. Sink stopper missing or damaged
8. Drain stop inoperable

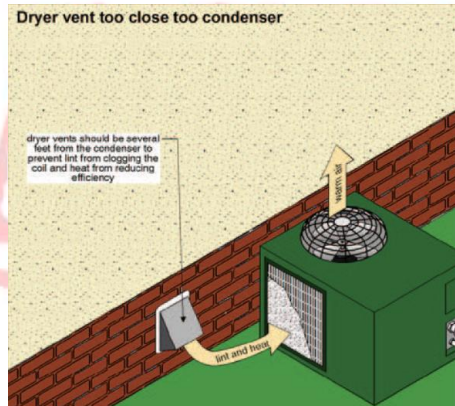
1. Dryer vent cover is loose, damaged or missing
2. Dryer is not vented properly to exterior wall or roof
3. Improper routing and length of vent pipe
4. Inadequate vent pipe material
5. Improper termination
6. Damaged or missing flapper termination
7. Dryer vent flapper is stuck in the open position
8. The lack of dryer vent system when provisions are present for a dryer

Written Opinion: The dryer vent appeared to be OK
